MOUSAM RIVER BASIN
SANFORD, MAINE

GOODALL-SANFORD DAM
ME-00185

PHASE I INSPECTION REPORT
NATIONAL DAM INSPECTION PROGRAM

JUNE 1979

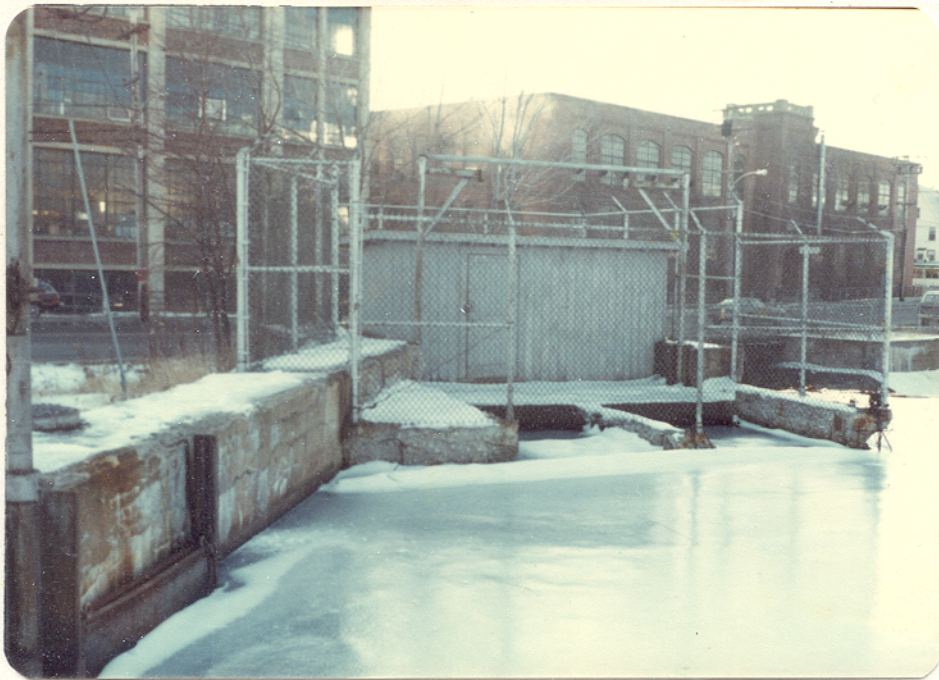
6

c. Appurtenant Structures. The control outlet consists of a 7-foot diameter sluiceway closed by a vertical lift timber gate. The gate and operating mechanism appear to be in fair condition. The lifting stems on the gate are badly corroded but intact. During periods of high flow, there is not suitable access to the operating mechanism of the control outlet.

Based on the visual inspection, the dam appears to be in fair condition. The concrete in the control outlet and process water headworks areas is in fair to poor condition with cracking and spalling evident. The catwalks crossing the downstream channel and connecting the mill buildings each side of the channel could collect debris and thus cause rapid flooding of street level areas within the mill buildings. As outlined in Section 7, rehabilitative construction and maintenance is necessary to assure the long-term safety of the structure.

GATED HEADWORKS

the east abutment and to make recommendations to eliminate or re-locate the catwalks downstream of the dam. Remedial measures include: 1) repair spalled and deteriorated concrete at the gated outlet and process water headworks structures; 2) remove trees from downstream channel; 3) repair badly corroded gate stems; 4) establish a formal warning system; 5) provide around-the-clock surveillance during heavy runoff periods; 6) institute a program of annual periodic technical inspection.

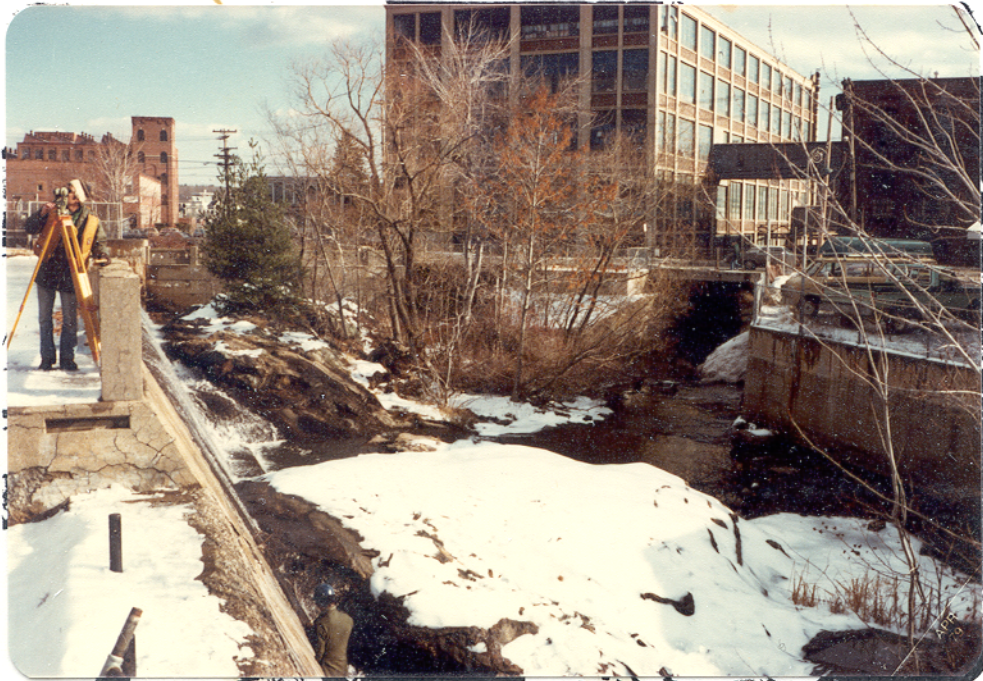
7

VIEW OF DOWNSTREAM CHANNEL
